**ROAD BLOCKER RB1000  
CRASH TESTED  
CERTIFICATION PAS68:2013  
ROAD BLOCKER  
V/7500(N3)/80 (K12) RATING**

Crash test - PAS68:2013 Road Blocker V/7500(N3)/80 (K12) Rating  
English Certification - PAS68:2013 Standard  
Performed at Aisico srl.  
Crash test Center , Pereto (Aq) - Italy

### ROAD BLOCKER 1000

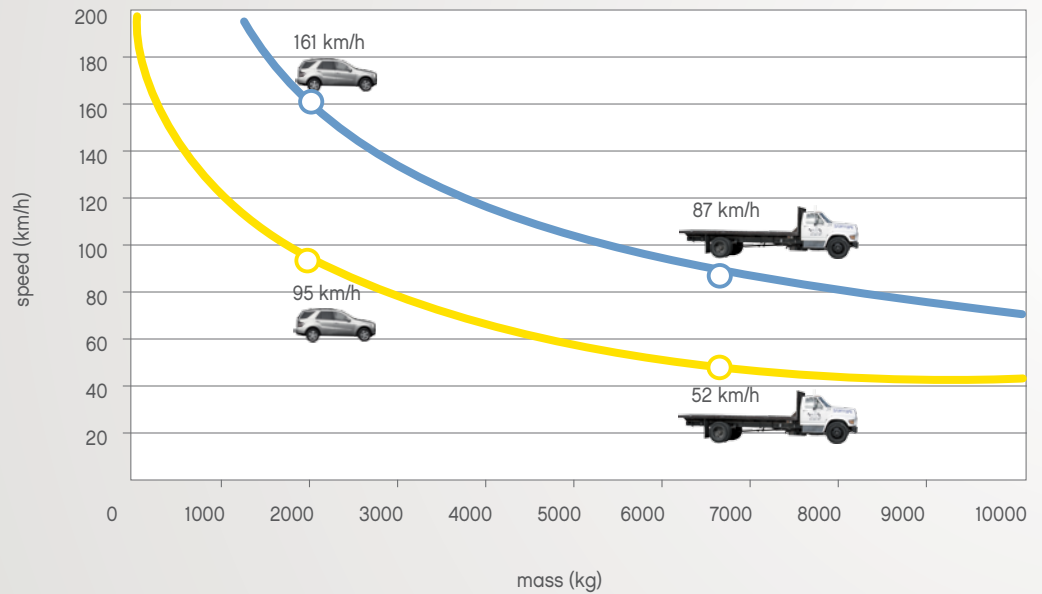
### BREAKOUT RESISTANCE

The resistance to breakage at a given threshold applies to the impact of a vehicle causing the Pilomat permanent damage in its active and structural mechanisms. The Pilomat, although damaged, provides the vehicle stop within a metre from the point of collision.

### IMPACT RESISTANCE

Resistance to impact at a given threshold indicates that the impact of a vehicle does not cause the PILOMAT blocking or damage to the structural and action mechanisms. The Pilomat's continued functionality and safety are guaranteed.

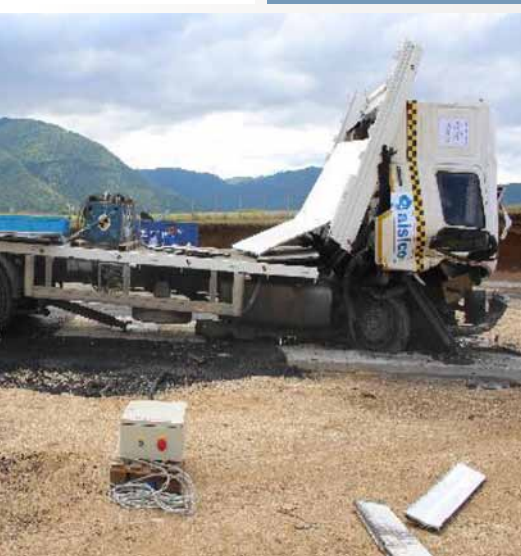
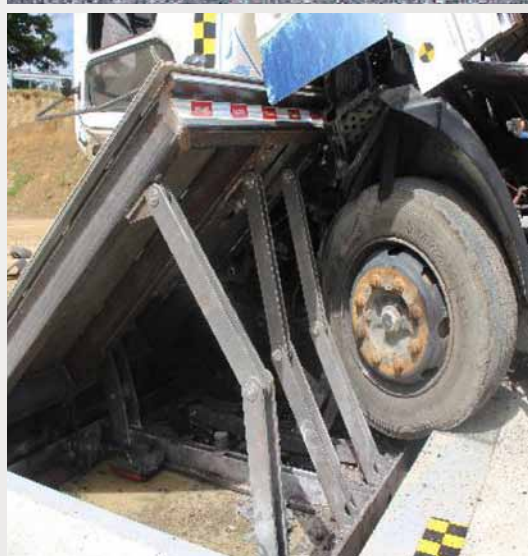
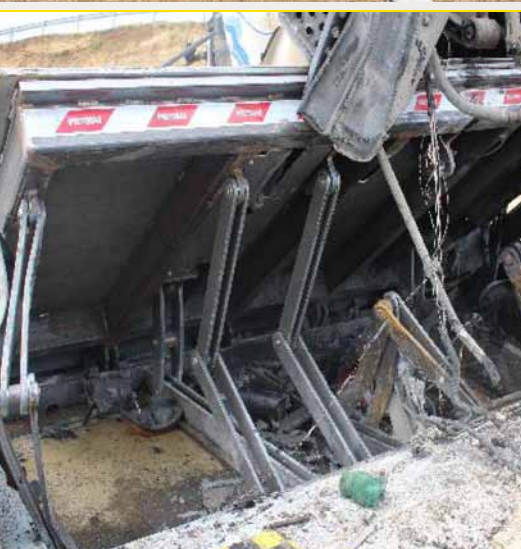
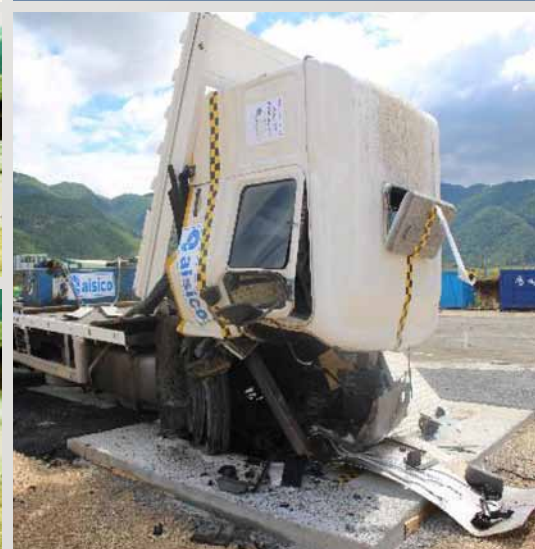
CRASH TEST

The test vehicle's forward motion was completely arrested by the PILOMAT ROAD BLOCKER RB1000. The maximum penetration was recorded dynamically on the passenger's side of the vehicle and was 0.2 m measured dynamically using high speed video.

The PILOMAT ROAD BLOCKER RB1000 sustained damage as result of the impact. The road blocker and foundation shifted, causing the road blocker to lean 10.0° in the direction of vehicle travel. Single item having a mass above of 25 kg, which, as a consequence of the impact has been entirely detached from the road blocker and has been projected beyond the original position of the road blocker for 10 m. The vehicle path remained blocked during and after the impact.

The foundation was in good condition without no visible cracks and shifted for 2 cm.

The PILOMAT ROAD BLOCKER RB1000 completely disabled the test vehicle causing severe damage to the chassis and drivetrain.
